# Manhole Inspection Summary

Manhole # S33EE\_043MH

Insp Date: **2/23/07 8:59 AM**

**Location** Address: **PARK AVE**

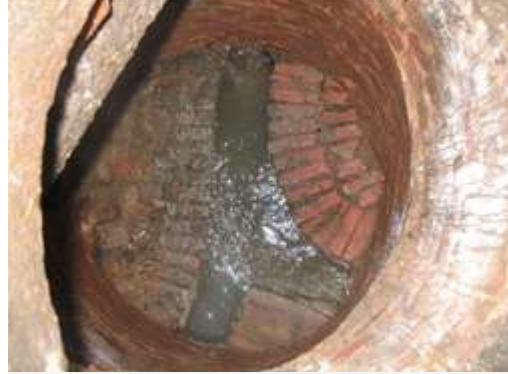
Top View

Evidence of surcharge - Bench debris.  
Channel debris.

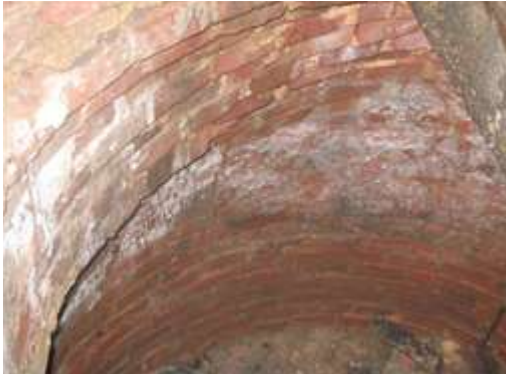
Defect

Adjustment, Corbel and Barrel infiltration.

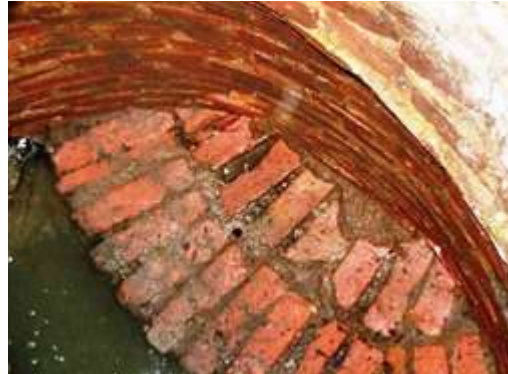
Defect

Bench deterioration..

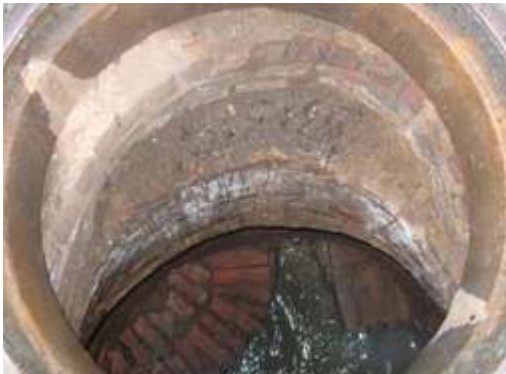
Defect

Frame leaks. Frame offset. Adjustment  
deterioration and infiltration. Corbel  
infiltration.

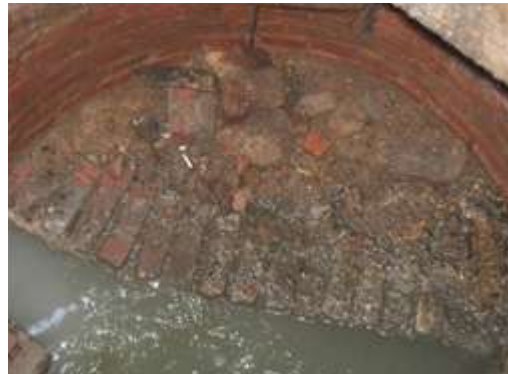
Defect

Evidence of surcharge - Bench debris.  
Corroded steps.

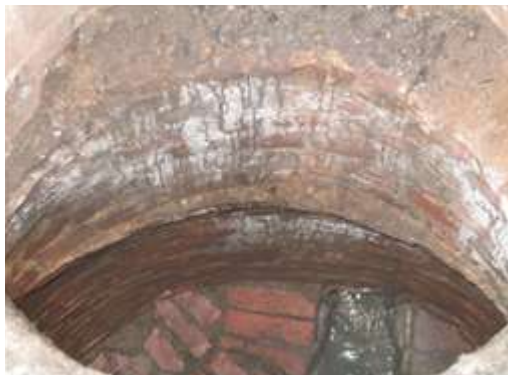
### Defect

Adjustment deterioration and infiltration.  
Corbel and Barrel infiltration.

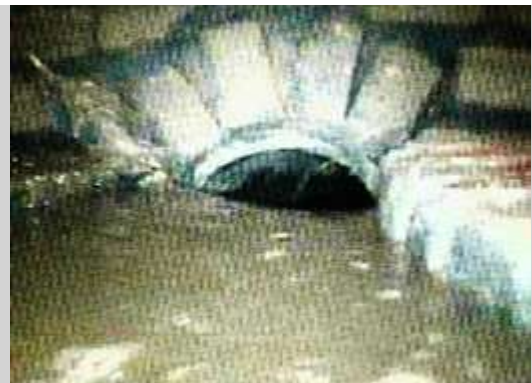
Pipe Out @ 12 O'Clock

Infiltration: **Evidence**

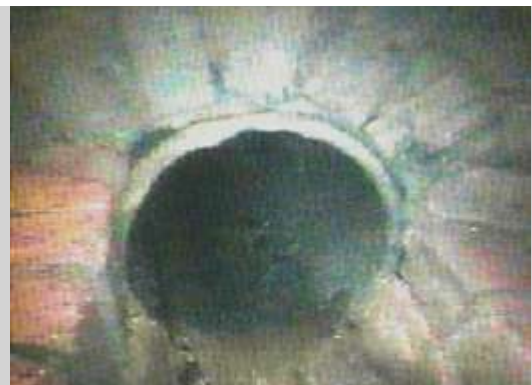
Pipe In @ 4 O'Clock

Infiltration: **Evidence**
